Gold King Mine

Silverton, San Juan County, Colorado

Project No. 0001/1408-01

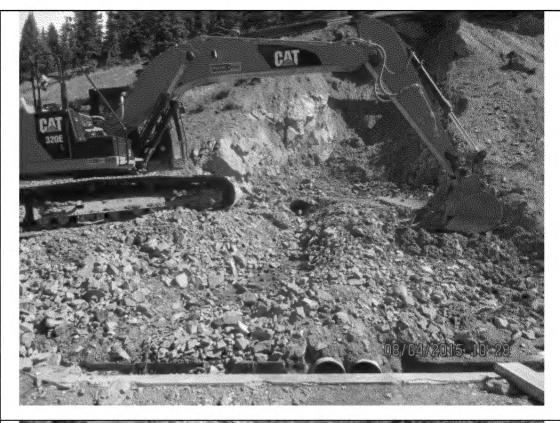
Photo No. 1

Beginning investigation into collapsed adit.

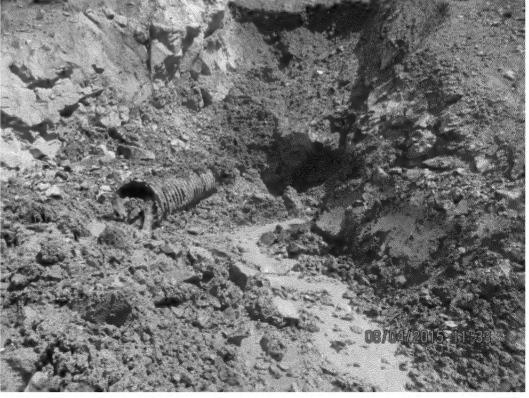
Photo No.

Excavated next to DRMS-installed culvert, water muddy from soil disturbance.

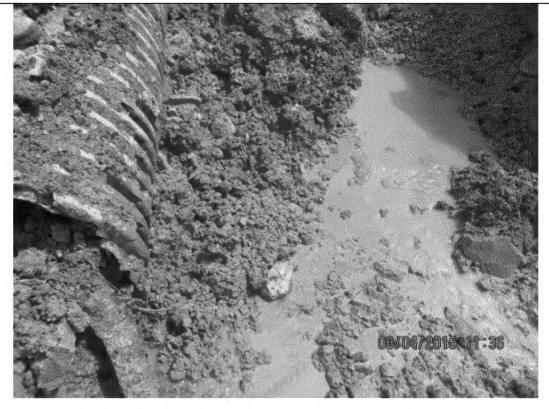
Photo No.

Seepage from soil next to piping.

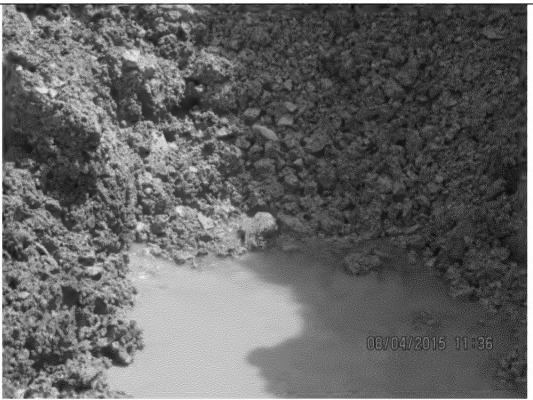
Photo No. 4

Seepage next to the pipe is clear until entering disturbed soil.

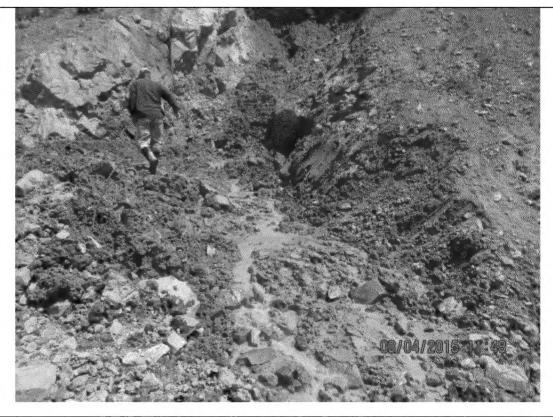
Photo No.

DRMS looking at adit excavation progress.

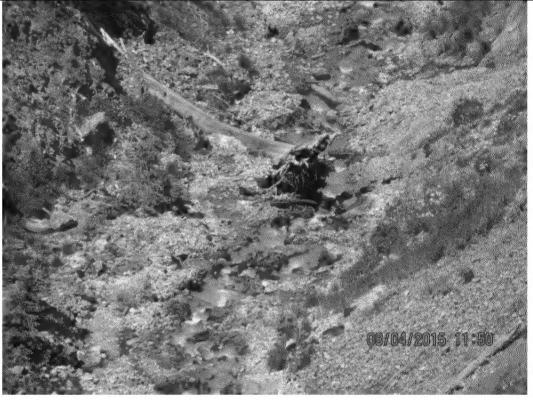
Photo No.

Water minimally murky from disturbed soil and water entering the North Fork from site.

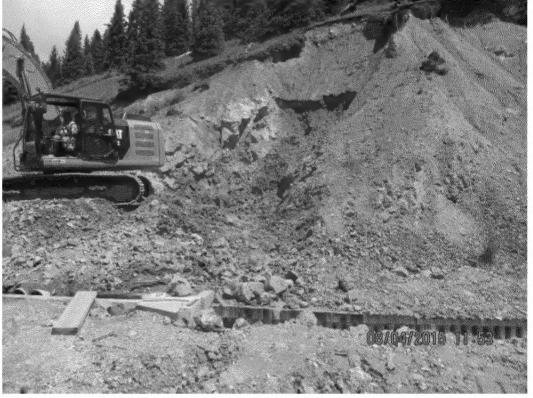
Photo No.

Continuing excavation at the collapsed adit, no solid bedrock found for tunnel support.

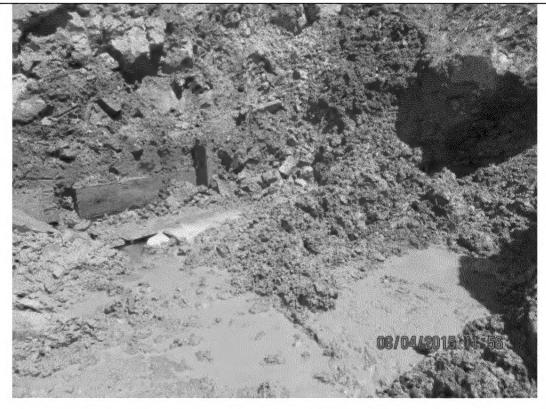
Photo No.

First signs of adit, support pillar with lagging.

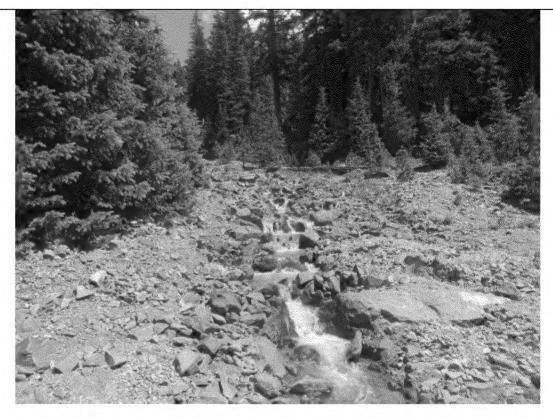
Photo No. 11

Water of the North Fork just upstream of Cement Creek.

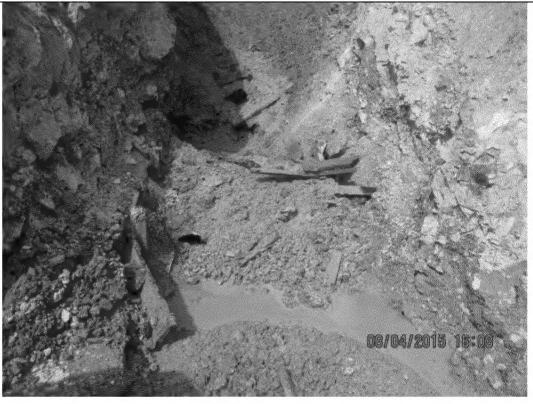
Photo No. 12

Collapsed supports uncovered above anticipated adit, no sign of bedrock above the adit area.

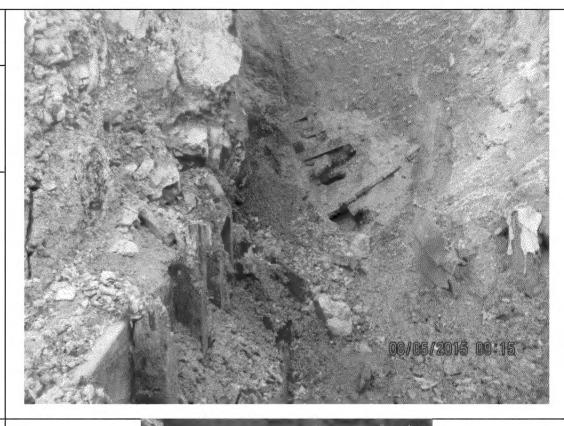
Photo No. 13

Description: Adit conditions the morning of 8/5.

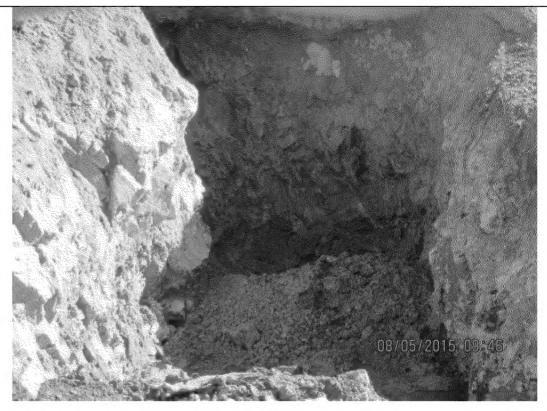
Photo No. 15

Bedrock found above the anticipated adit.

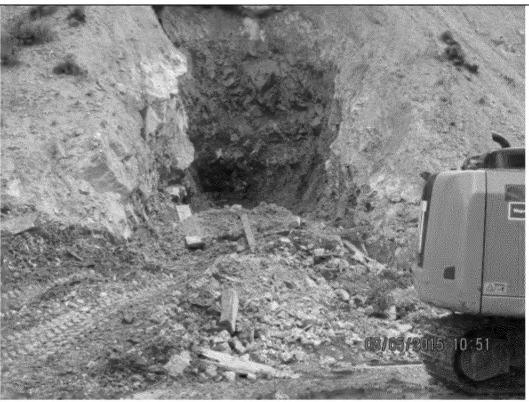
Photo No. 16

Cleaning out excavated material, small leak.

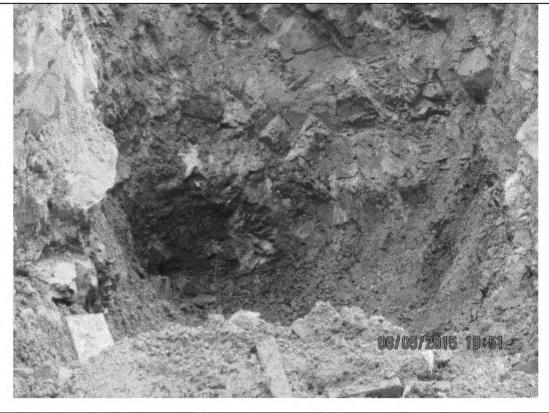
Photo No. 17

Description: Small leak close up.

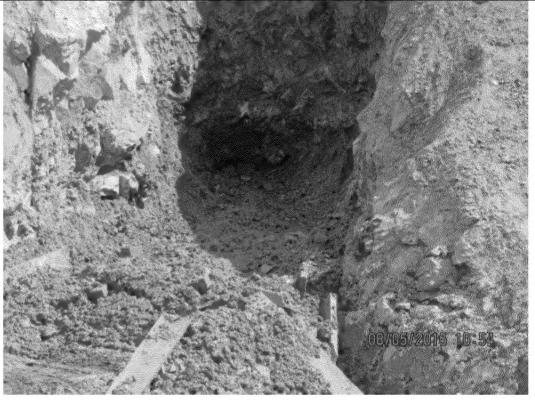
Photo No. 18

Description:Hole starting to give way to flow.

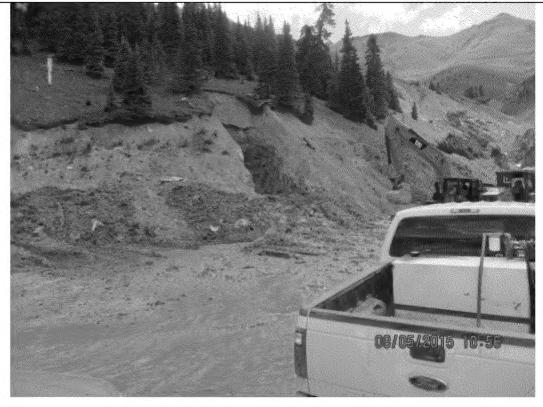
Photo No. 19

Adit flow increasing.

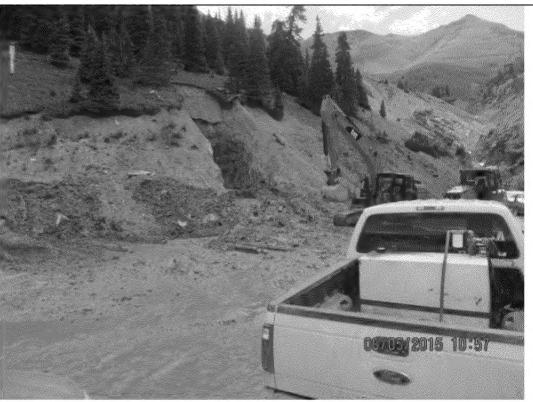
Photo No. 20

Water flooding out at increased rate.

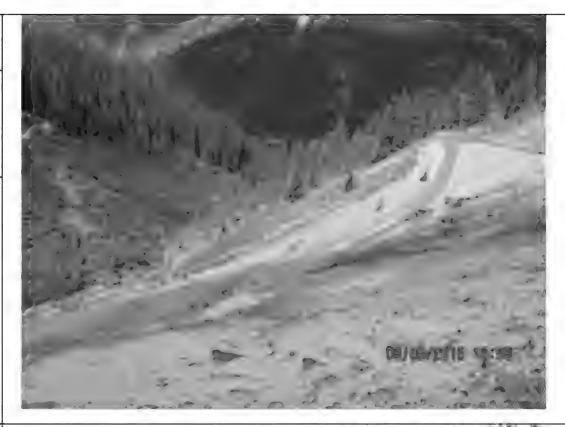
Photo No. 21

Water flowing along access road and across waste dump

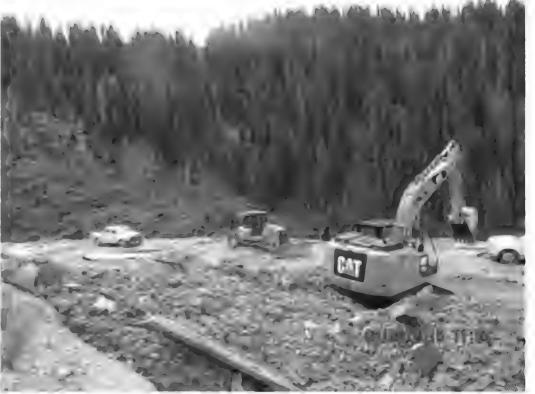
Photo No. 22

Water flowing over the edge of the waste dump and collapsing the edge

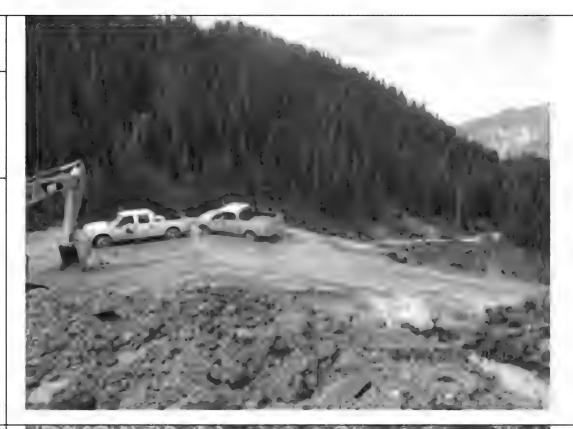
Photo No. 23

Exit route starting to collapse

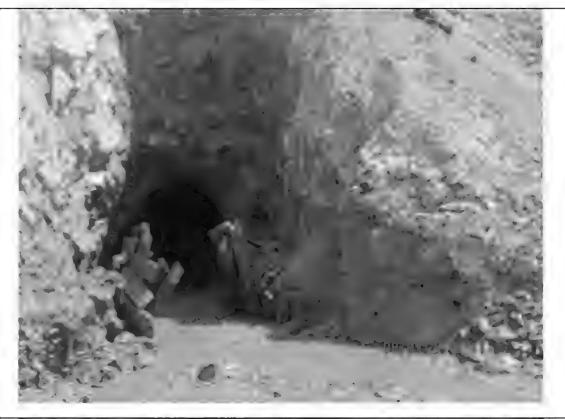
Photo No. 27

Exposed adit, roughly 10 feet wide by 15 feet high.

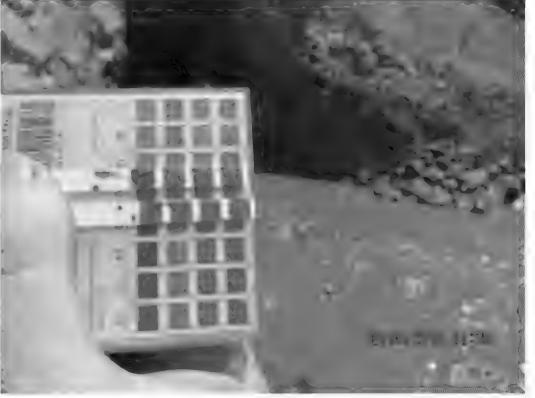
Photo No. 28

pH of discharge water is approximately 4 to 4.5.

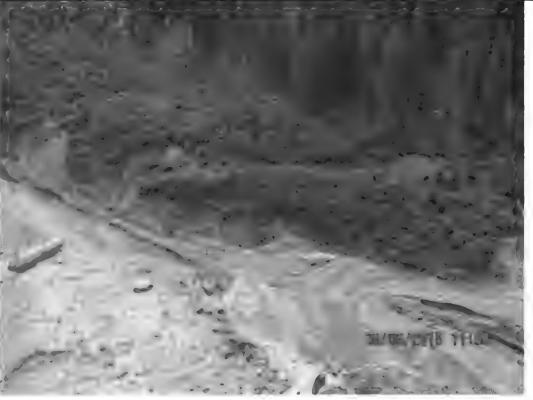
Photo No 30

Collapsed portion of waste dump and road wash out.

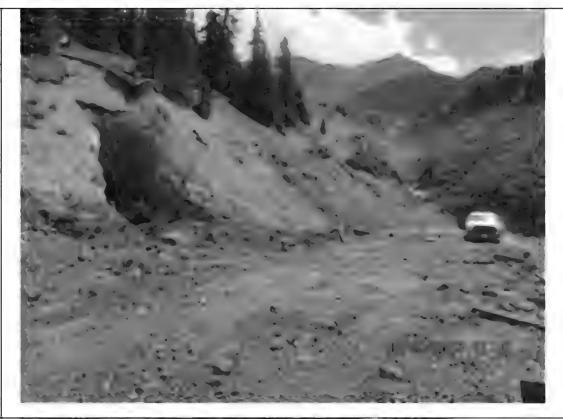
Description: Adit area after regrading.

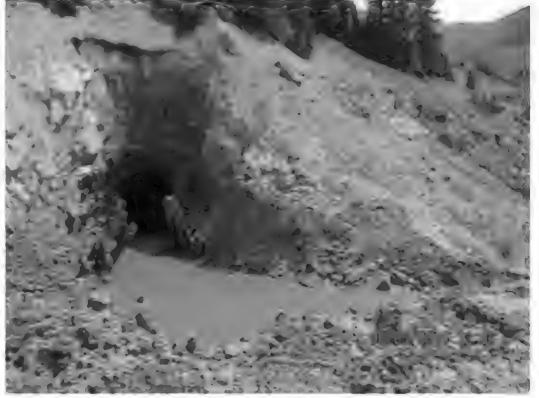
Photo No. 32

Description: Exposed adit and redirected flow, flow is

beginning to subside.

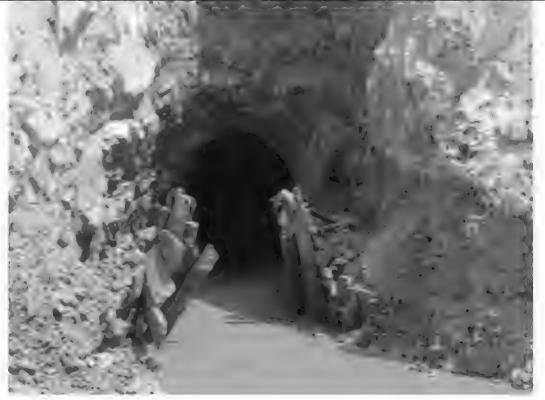
Photo No. 34

Description: Closeup of adit

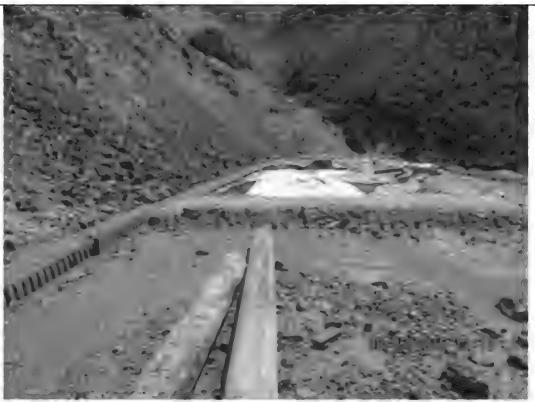
Photo No 36

Existing flow channel at maximum capacity

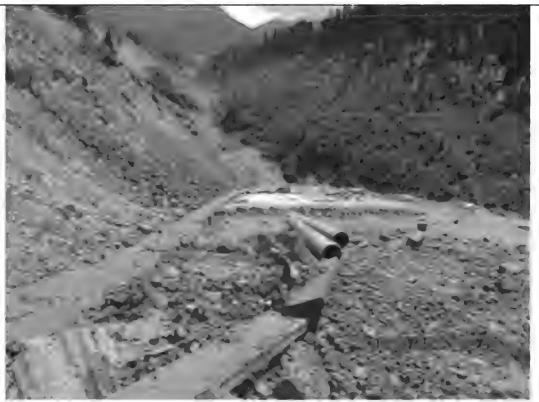
Photo No. 38

Existing culvert flows subsiding minimally.

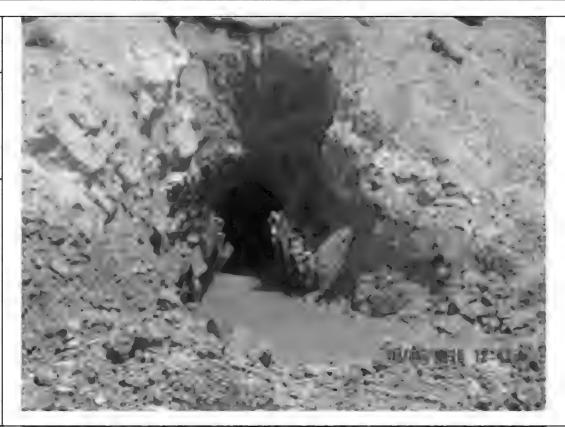
Photo No. 39

No changes visible in adit structure or supports. Sloughing of materials inside the mine can be heard.

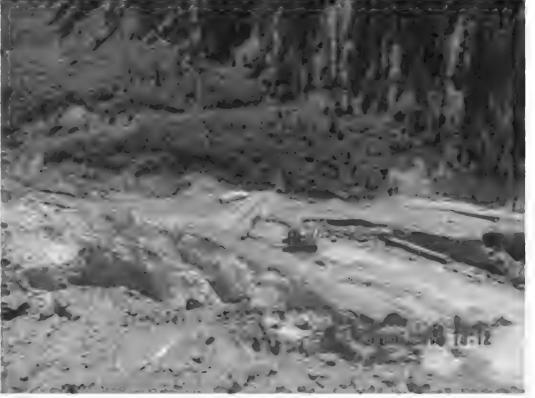
Photo No. 40

Excavator progresses to washed out North Fork crossing.

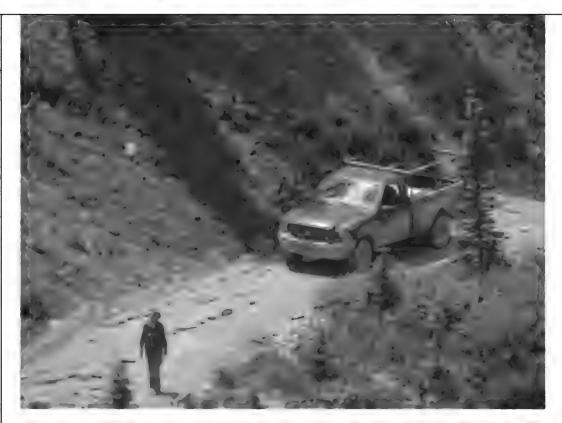
Noted visitor to the site, unknown person, walked up to excavator at North Fork crossing and then back to vehicle.

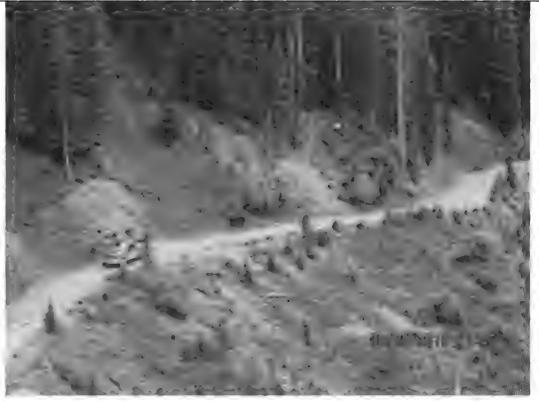
Photo No 42

Description: Visitor leaving

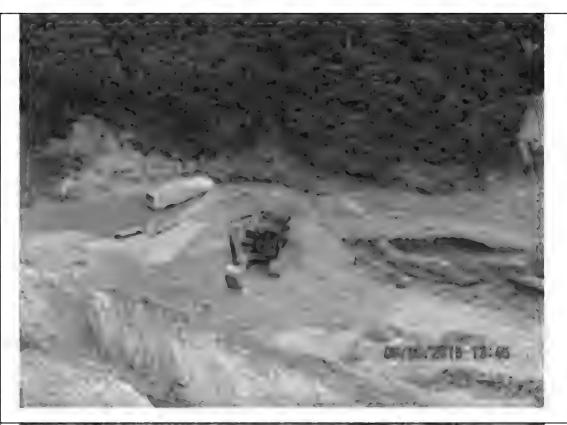
Photo No. 43

Excavator continues to fix access road.
Continued high flow is slowing progress.

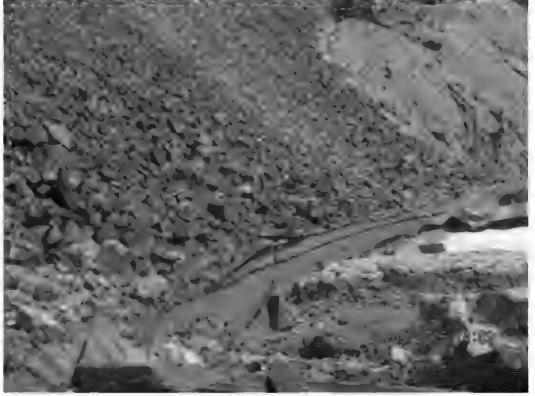
Photo No. 44

Description: Half culvert flow continues to subside

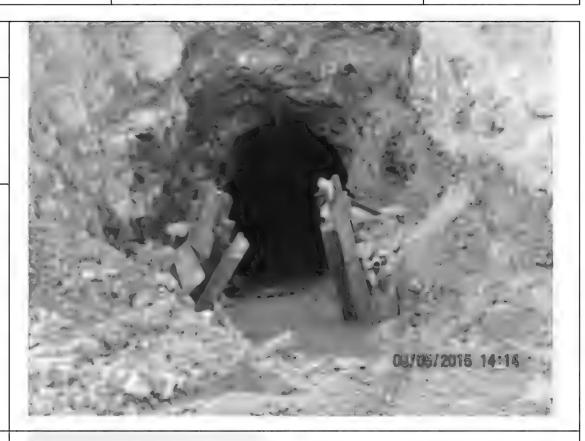
Photo No. 45

Water levels lowering at adit entrance, no visible changes to structure.

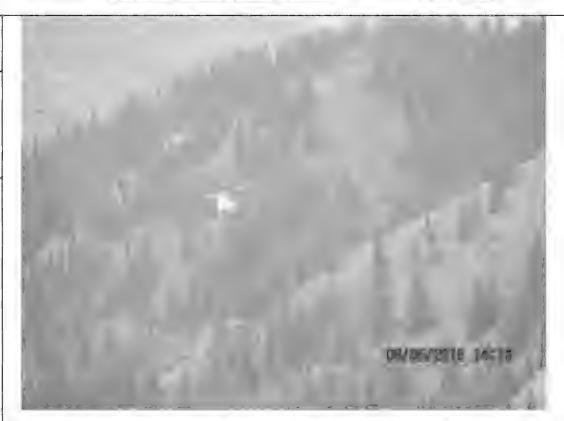
Photo No. 47

Close up of Flight for Life.

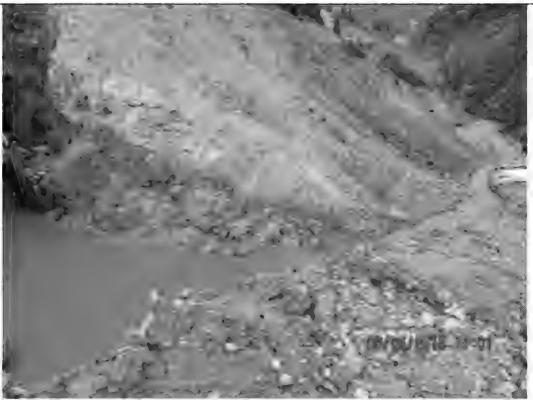
Photo No. 48

Flow path from adit, water flow appears to have stabilized around 1400.

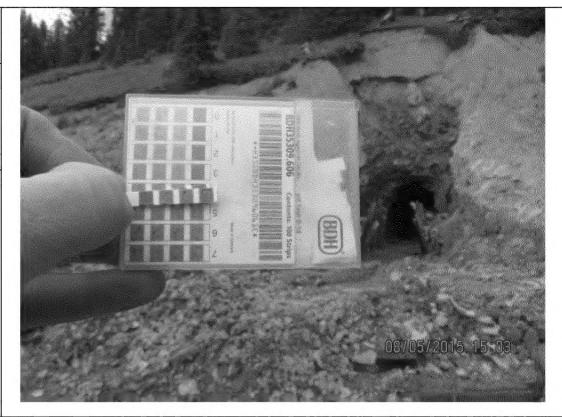
Photo No. 49

pH measured at approximately 4.5.

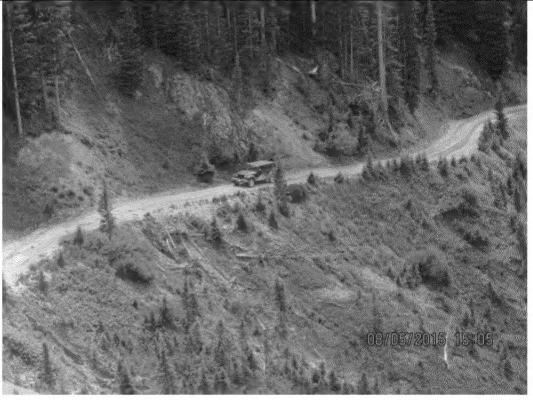
DRMS arrives back on site, had visited the site around 0930 to check on progress of investigation, left approximately 1030, prior to blowout.

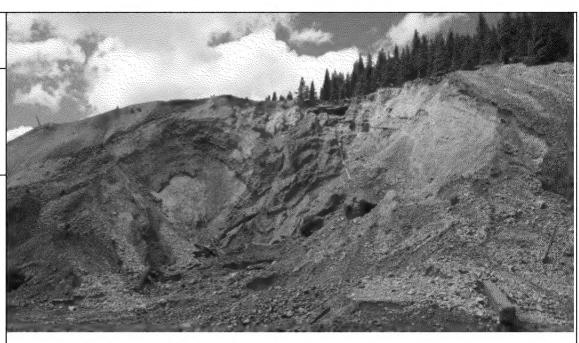
Looking up from the toe of the Gold King waste dump directly south of the adit.

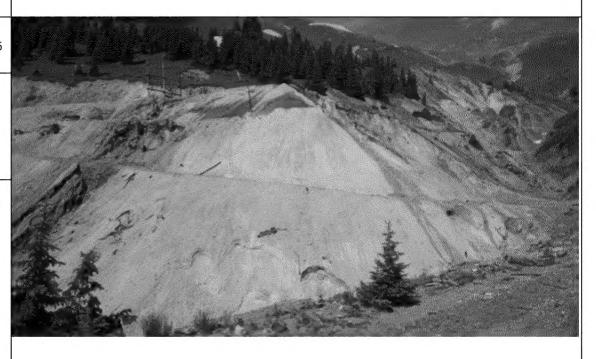
Photo No. **52**

Gold King Mine tailings dump after water discharge.

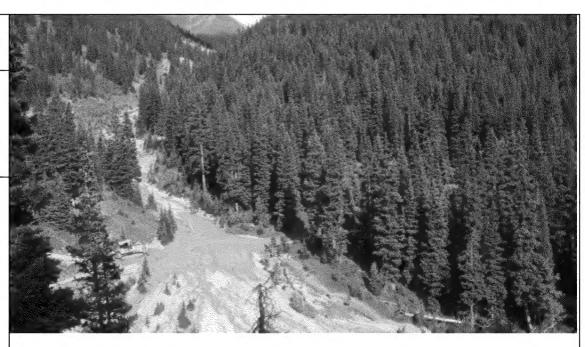
Photo No. 53

Looking east across Cement Creek from County Road 10 to excavator fixing County Road 52 at North Fork crossing just south of Red and Bonita Mine.

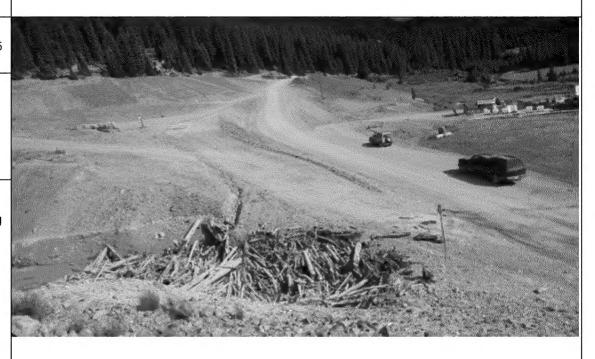
Cement Creek crossing at Gladstone.
